SUBJECT: Recommendations and HRS considerations for the **Big River Mine**
Tailing site in Desloge, Missouri
TDD #F-07-8711-039 PAN #FM00616PA
Site #Y60 Project #001
Superfund Contact: Gene Gunn

Preliminary Assessment
Big River Mine Tailings
Desloge, St. Francois County, Missouri
TDD #F-07-8711-039 PAN #FM00616PA
Site #Y60 Project #001
Submitted to: Paul E. Doherty, RPO
Task Leader: Robert Overfelt, E & E/FIT
Superfund Contact: Gene Gunn
Date: May 17, 1988

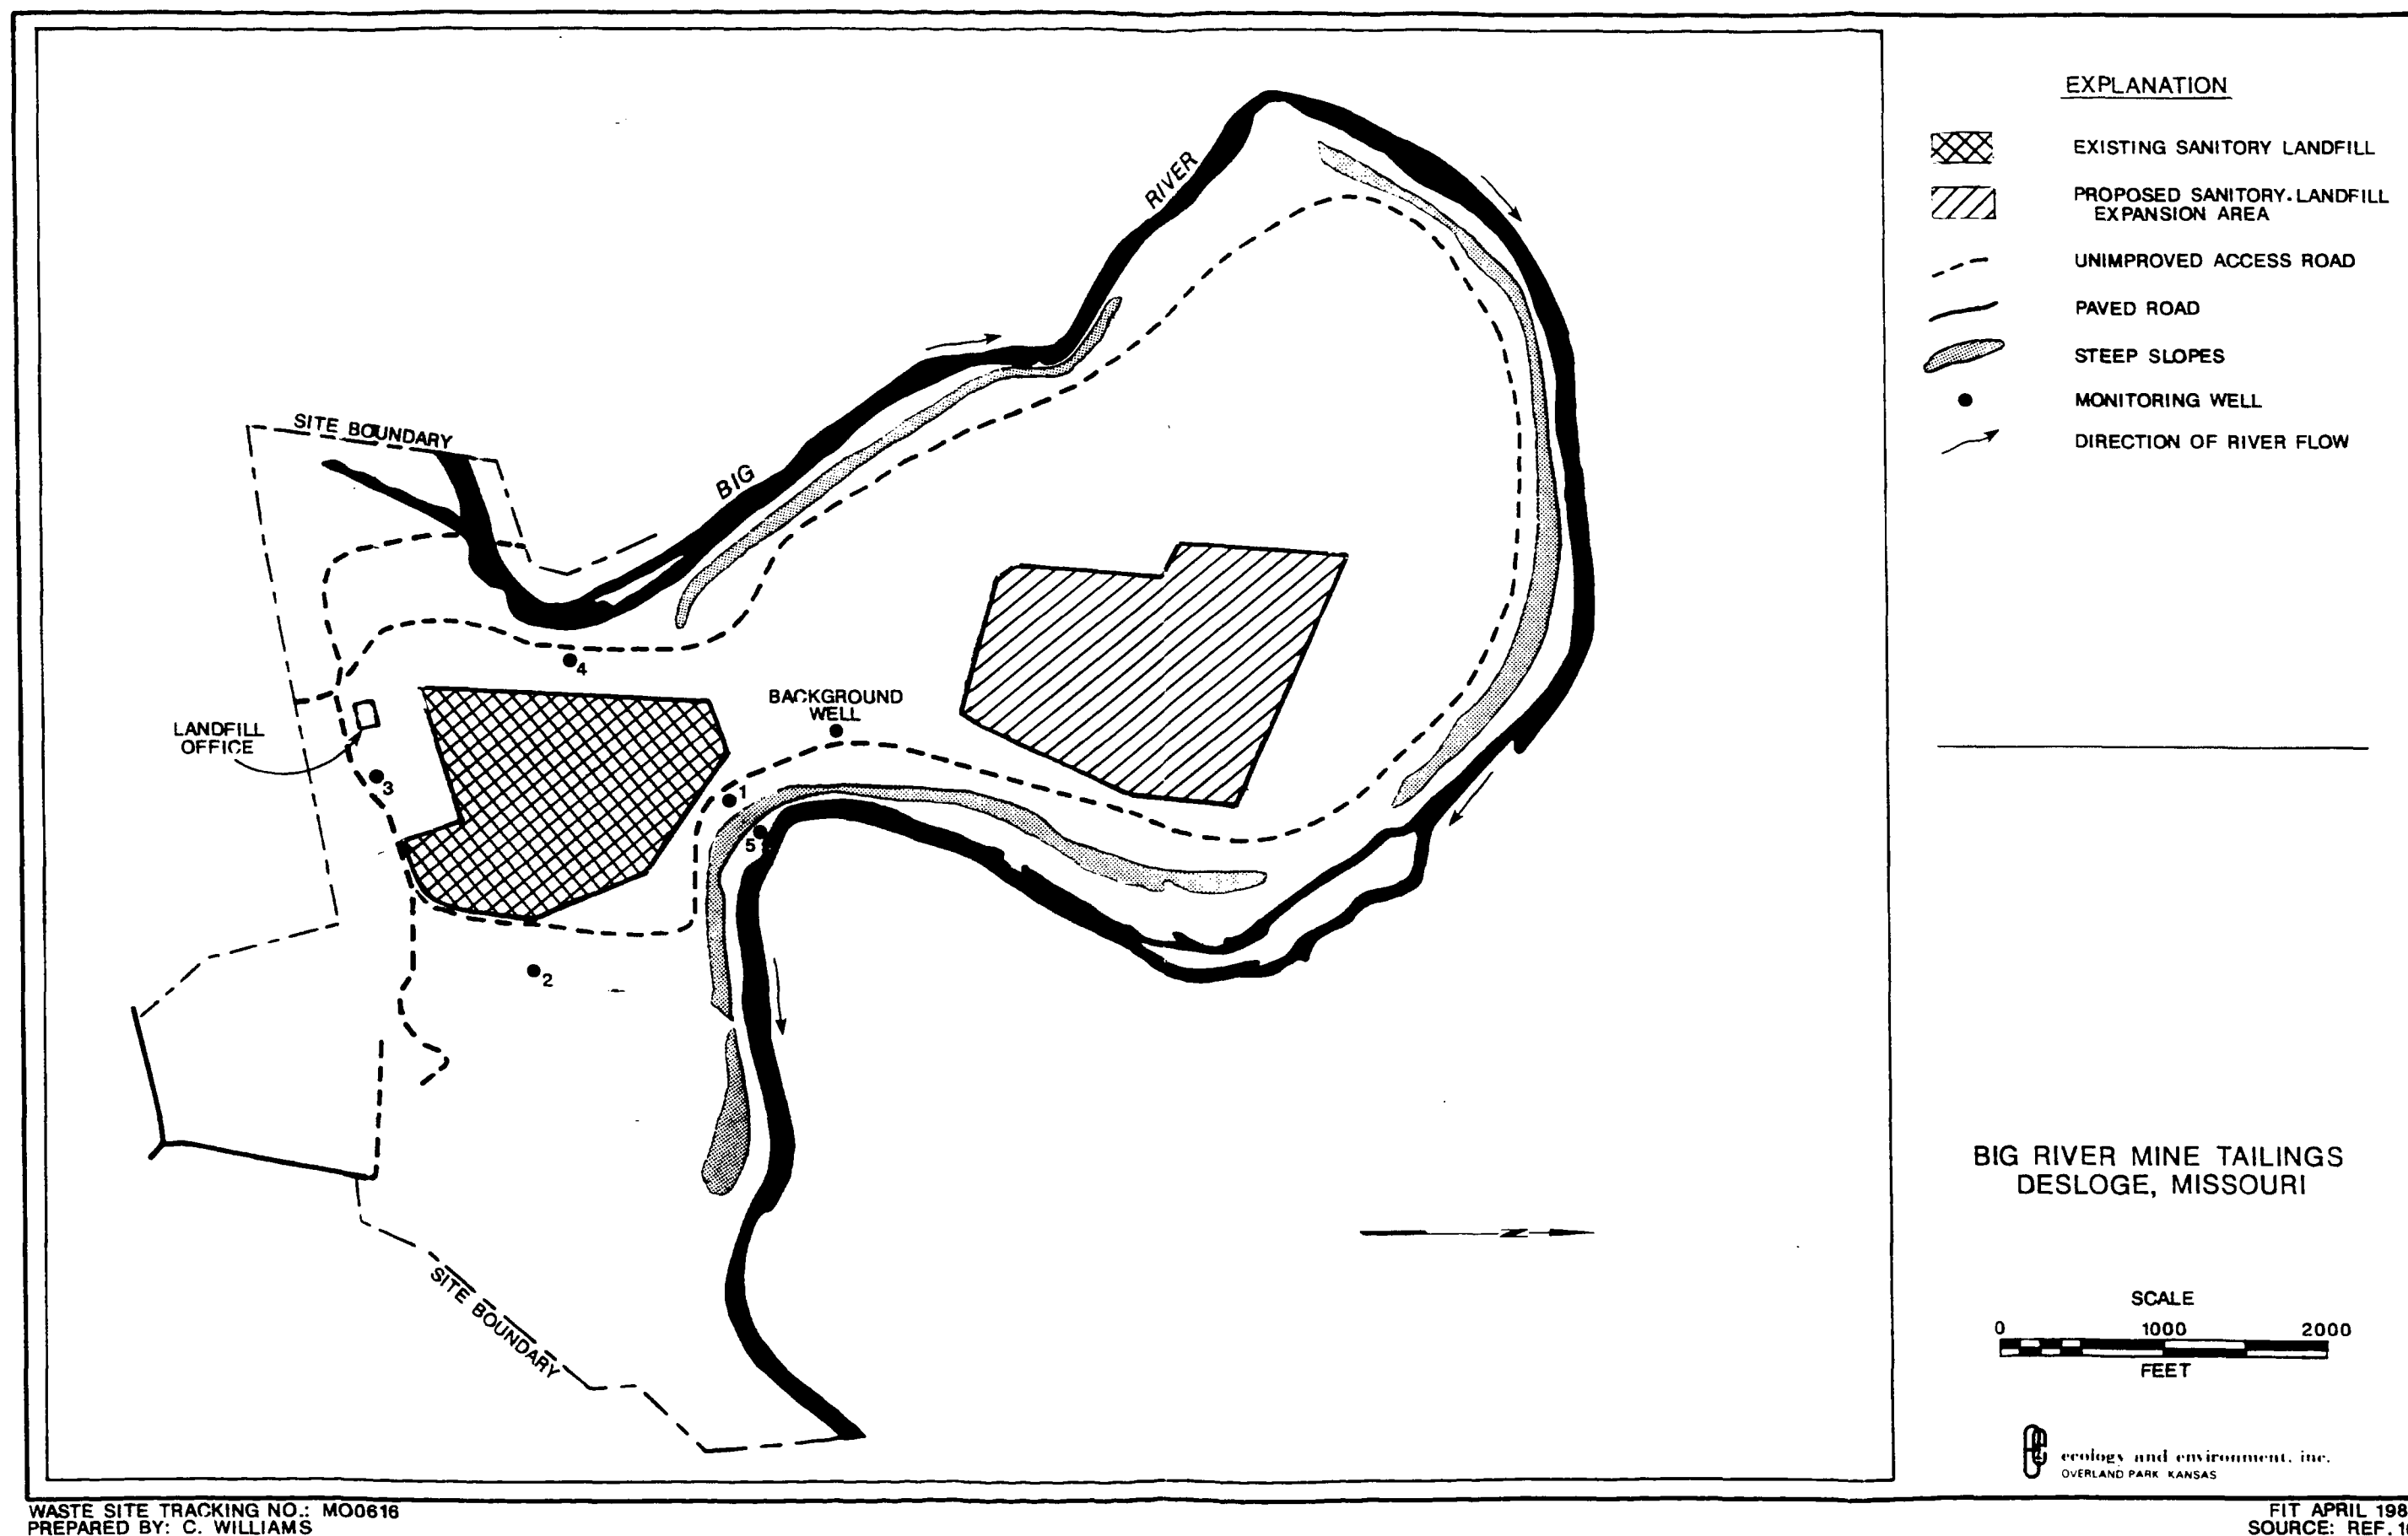
FIGURE 2: SITE MAP

The Big River Mine Tailings site covers approximately 600 acres (Figure 2). It consists mainly of mine tailings ranging from 0 to 100 feet deep (Ref. 2). A sanitary landfill and landfill office are located on the south end of the site. The landfill is operated by the St. Francois County Environmental Corporation which has a state permit to fill approximately 60 acres (Ref. 3). There are six monitoring wells installed around the landfill and the well logs are included as Appendix B. The majority of the site is situated within a horseshoe meander of the Big River (Figure 2).
